**Investigating the Mechanism of Transgranular Stress Corrosion
Cracking in Near-Neutral pH Environments on Buried Fuel
Transmission Pipelines**

A Dissertation
Presented to
The Academic Faculty

Georgia Institute of Technology
December 2007

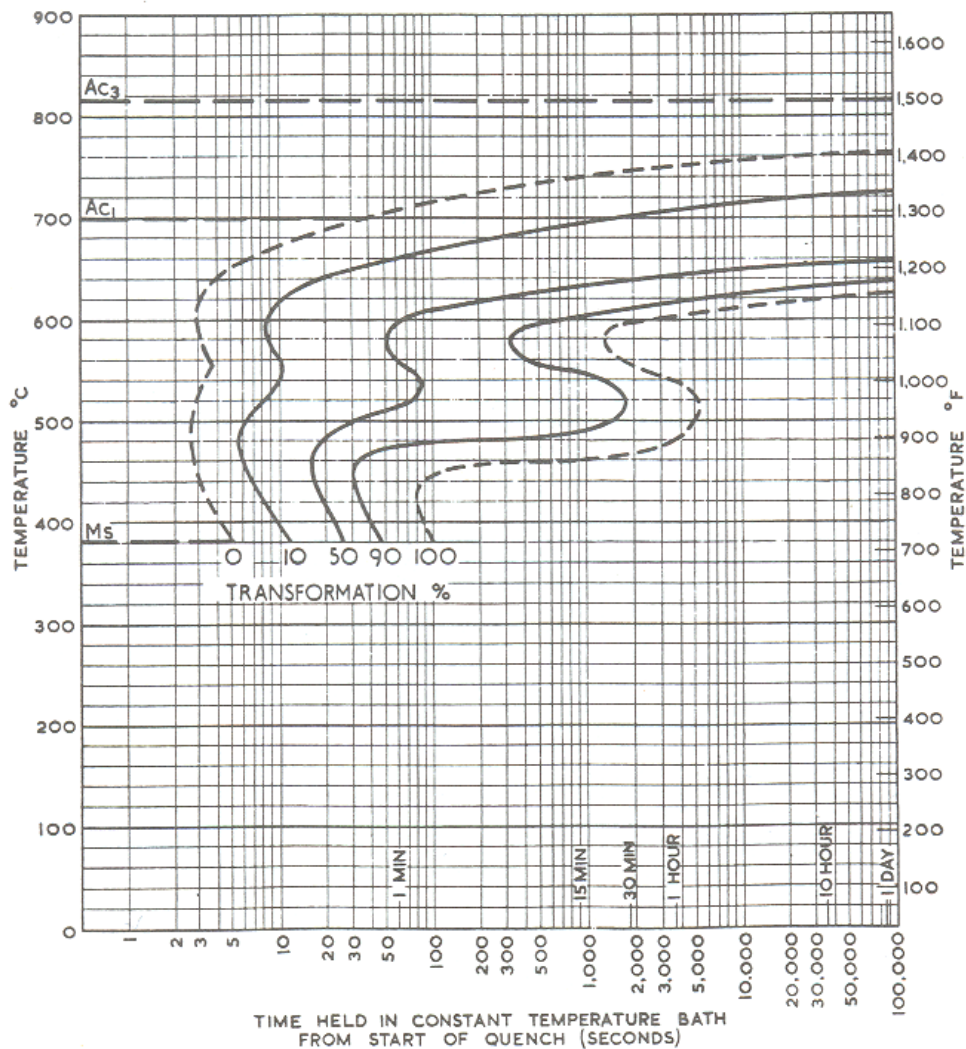
Figure 8 - Time-Temperature-Transformation diagram for 1527 steel which is the British equivalent to X-65 pipeline steel. Data provided by The Iron and Steel Institute [95]

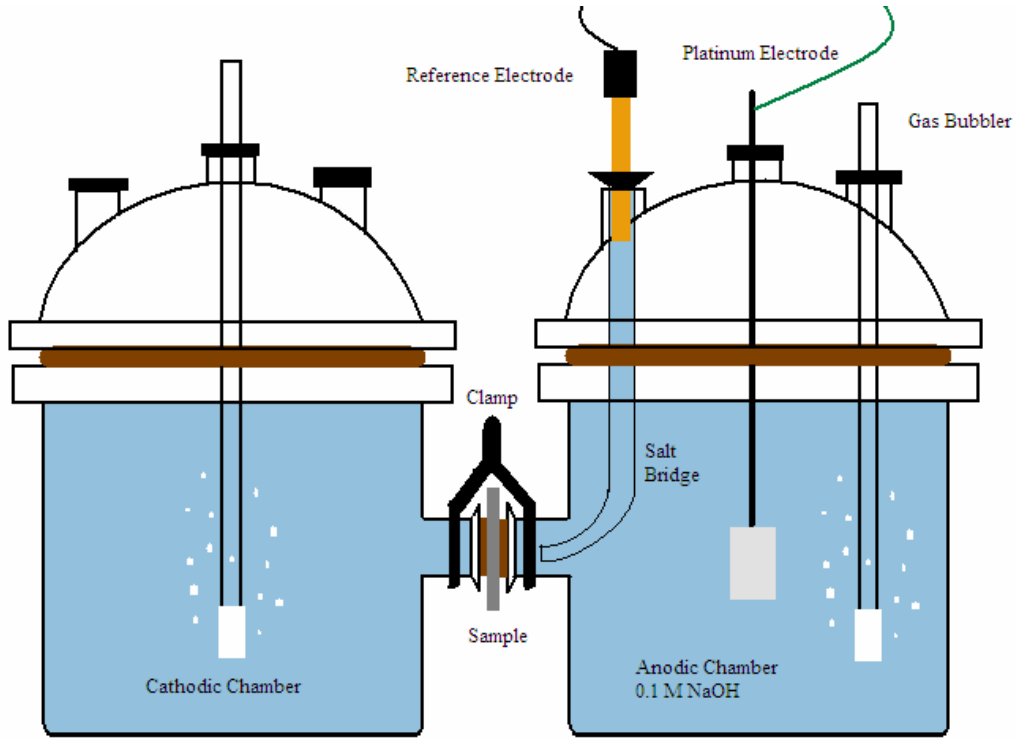
Figure 9 - Schematic of Devanathan Hydrogen Permeation Setup

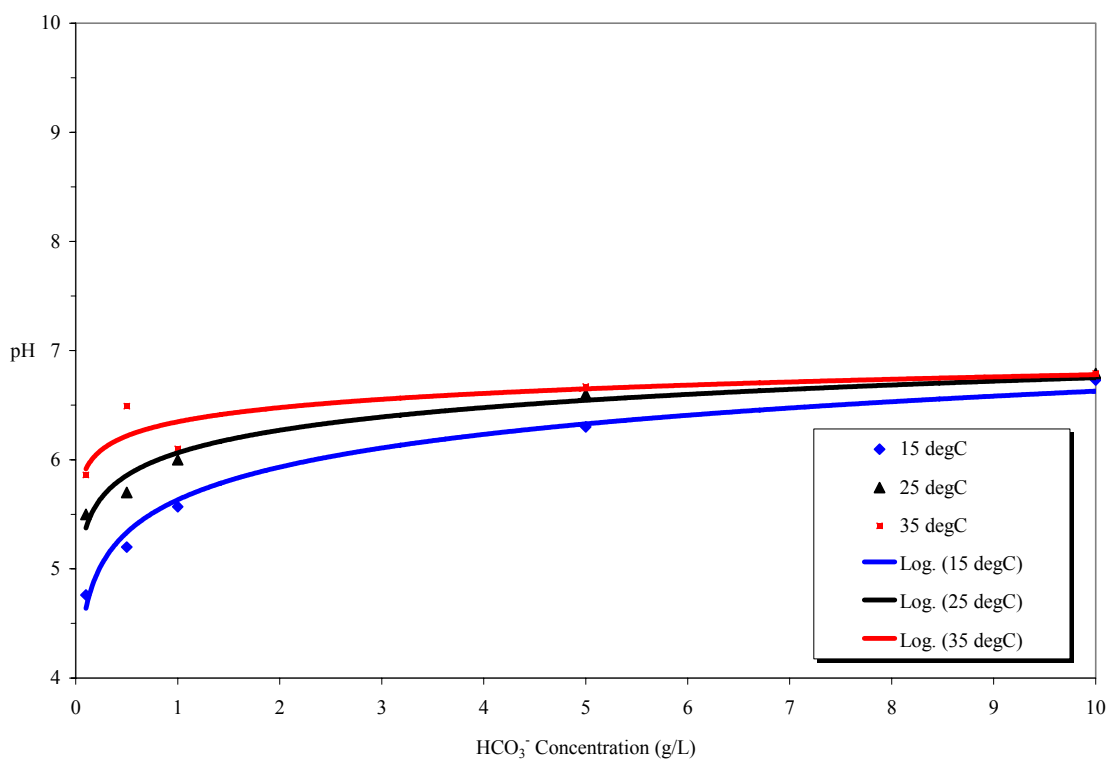
Figure 11 - pH values after 72 hours as a function of bicarbonate concentration at 15°C, 25°C and 35°C with 100% CO_2 bubbled through the solution.

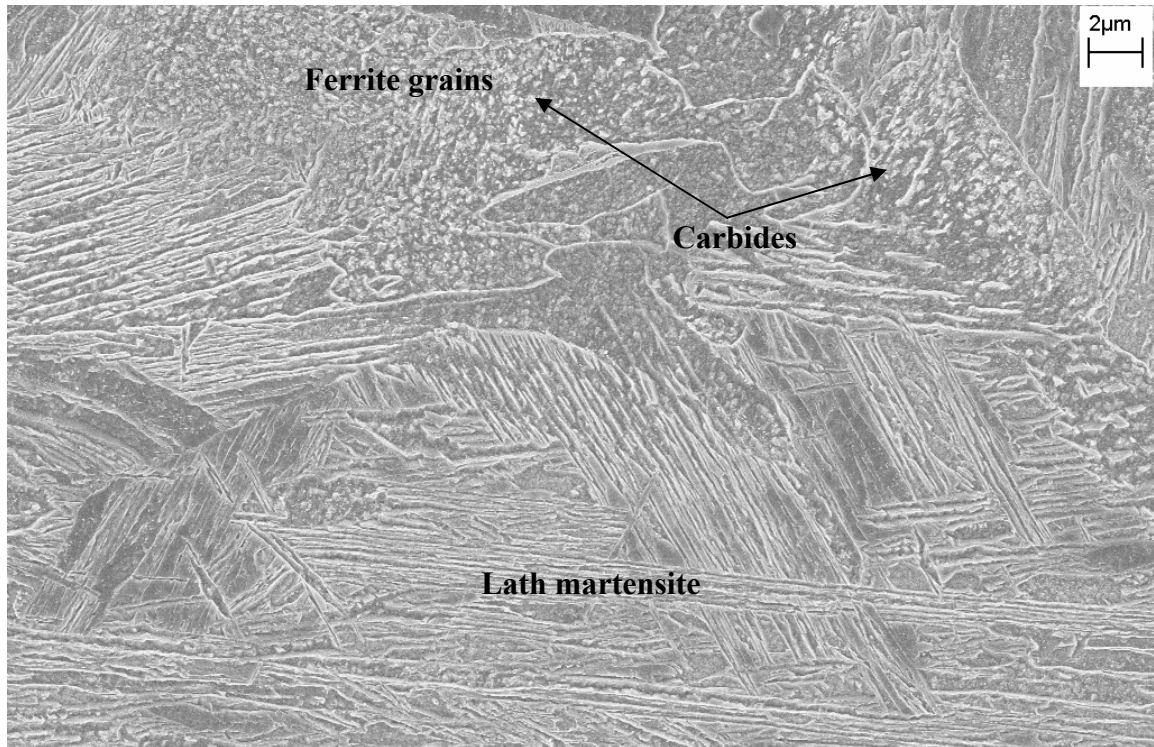
Figure 16 - Microstructure of Annealed and Water Quenched (AWQ) pipeline steel showing lath martensite with ferrite grains.

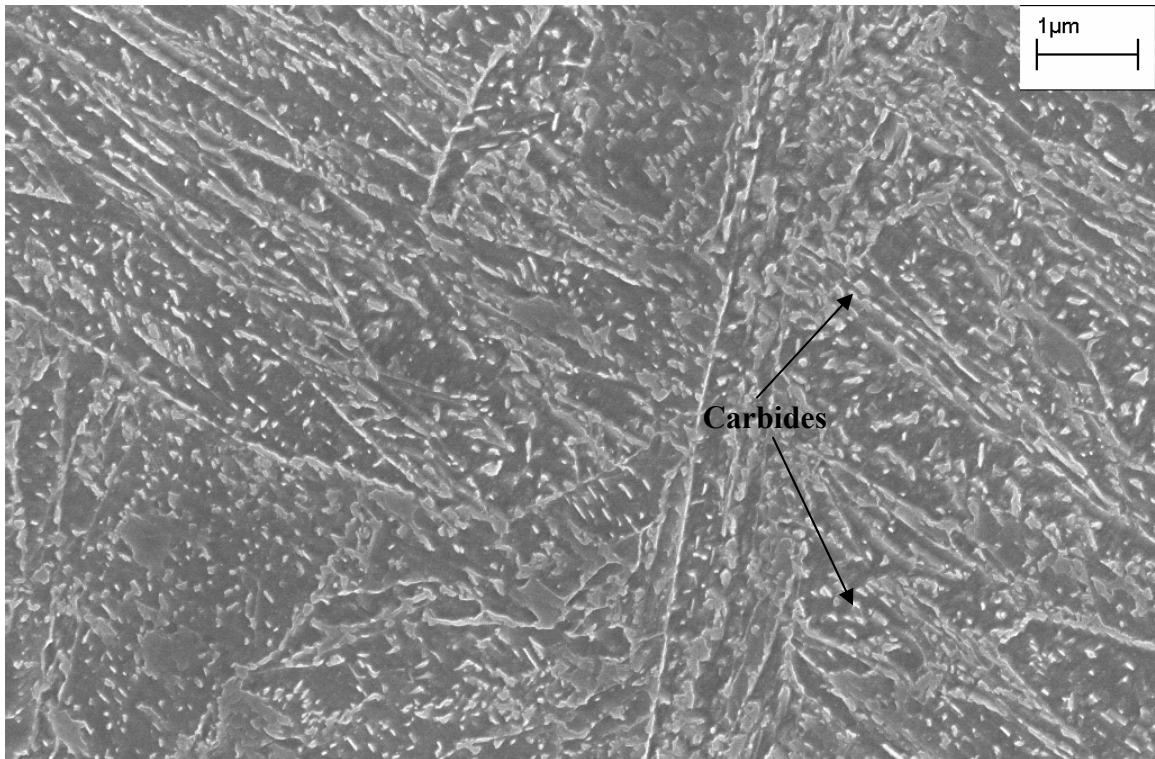
Figure 19 - SEM of microstructure of Tempered 350°C pipeline sample. Carbides appear as lighter phase stand in relief from the grey ferrite

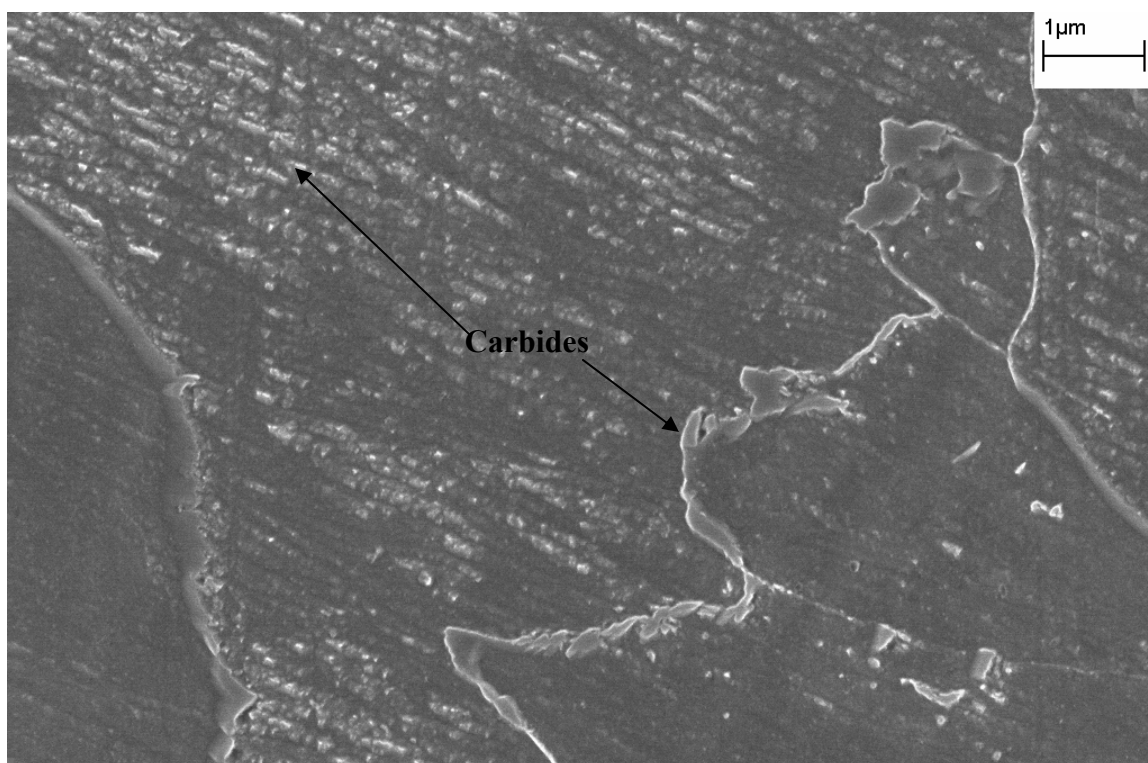
Figure 20 - SEM of microstructure of Tempered 400°C pipeline sample. Carbides appear as lighter phase and stand in relief from the dark grey ferrite

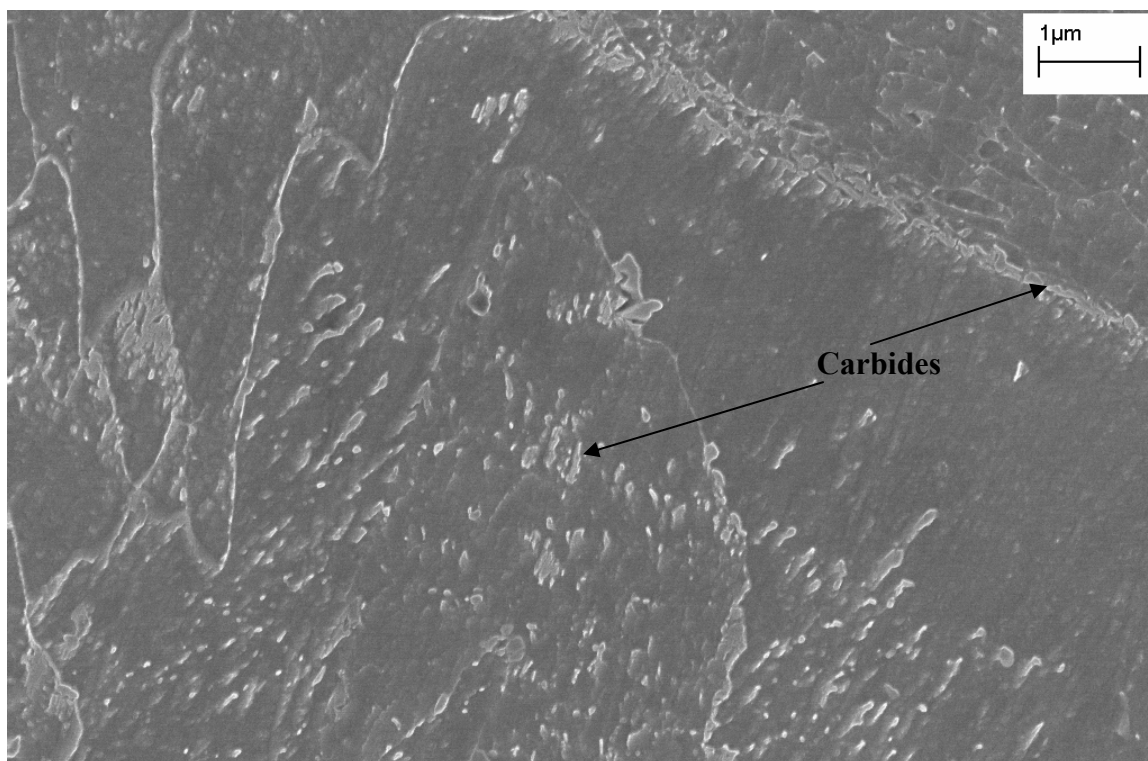
Figure 21 - SEM of microstructure of Tempered 475°C pipeline sample. Carbides appear as lighter phase and stand in relief from the darker ferrite

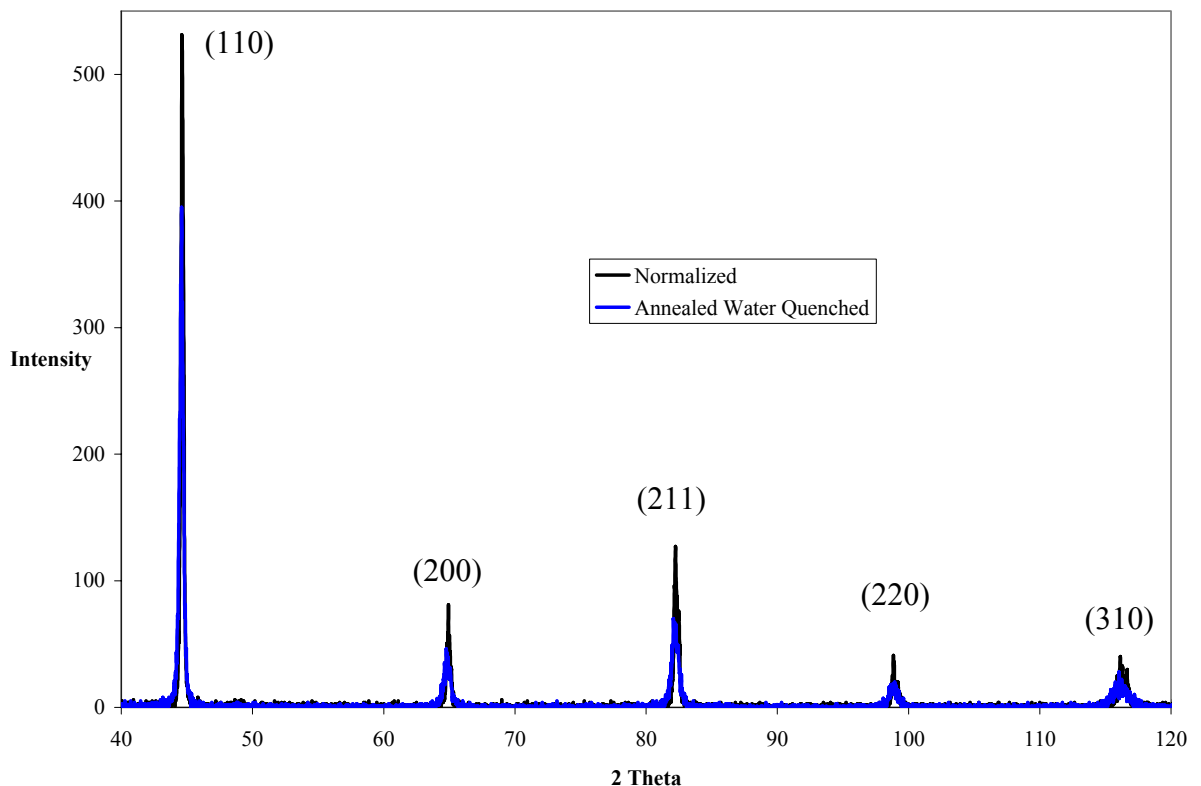
Figure 22 - Representative XRD peaks for Normalized and Annealed Water Quenched samples with peak families identified

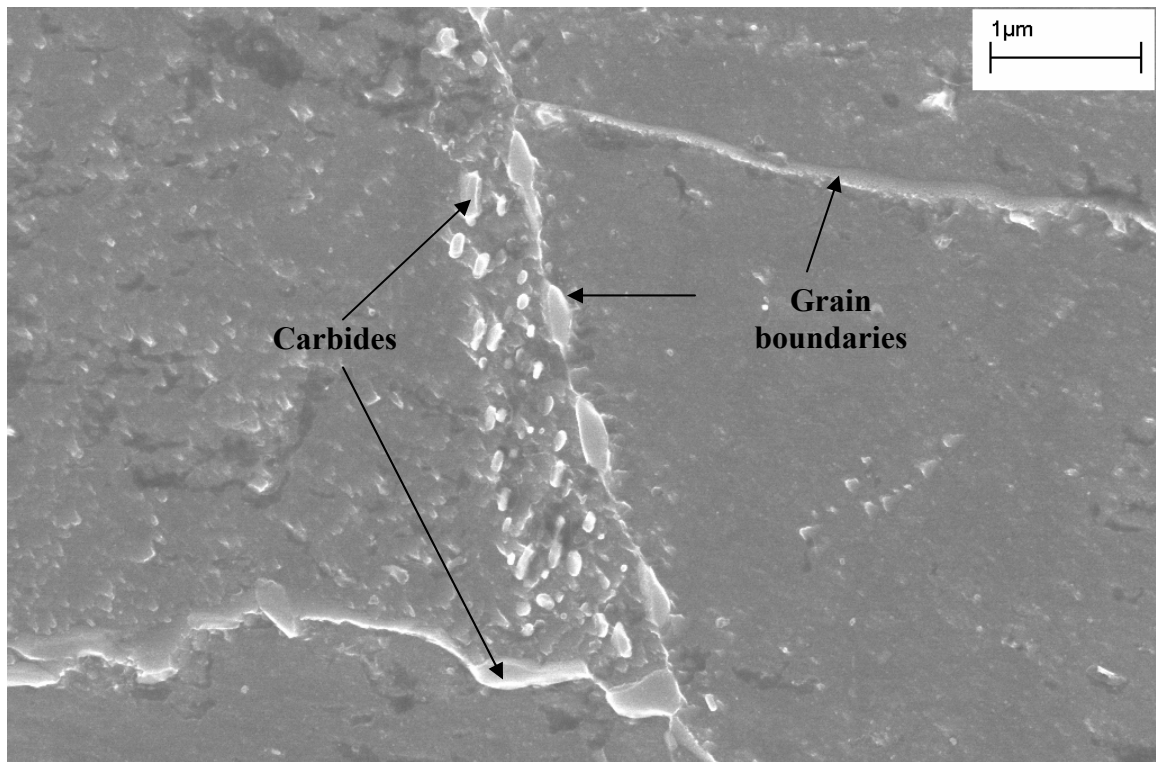
Figure 23 - SEM image of the microstructure of Temper 650°C for 1 hour.

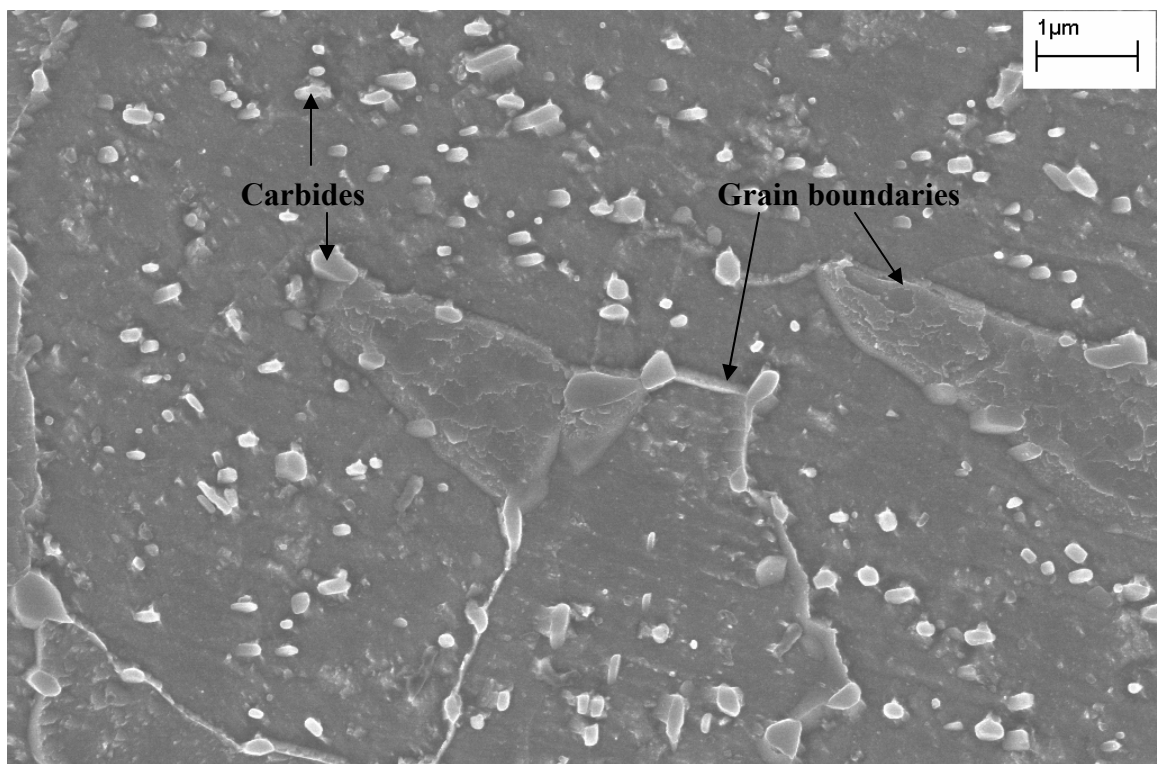
Figure 24 - SEM image of the microstructure of Tempered 650°C for one day.

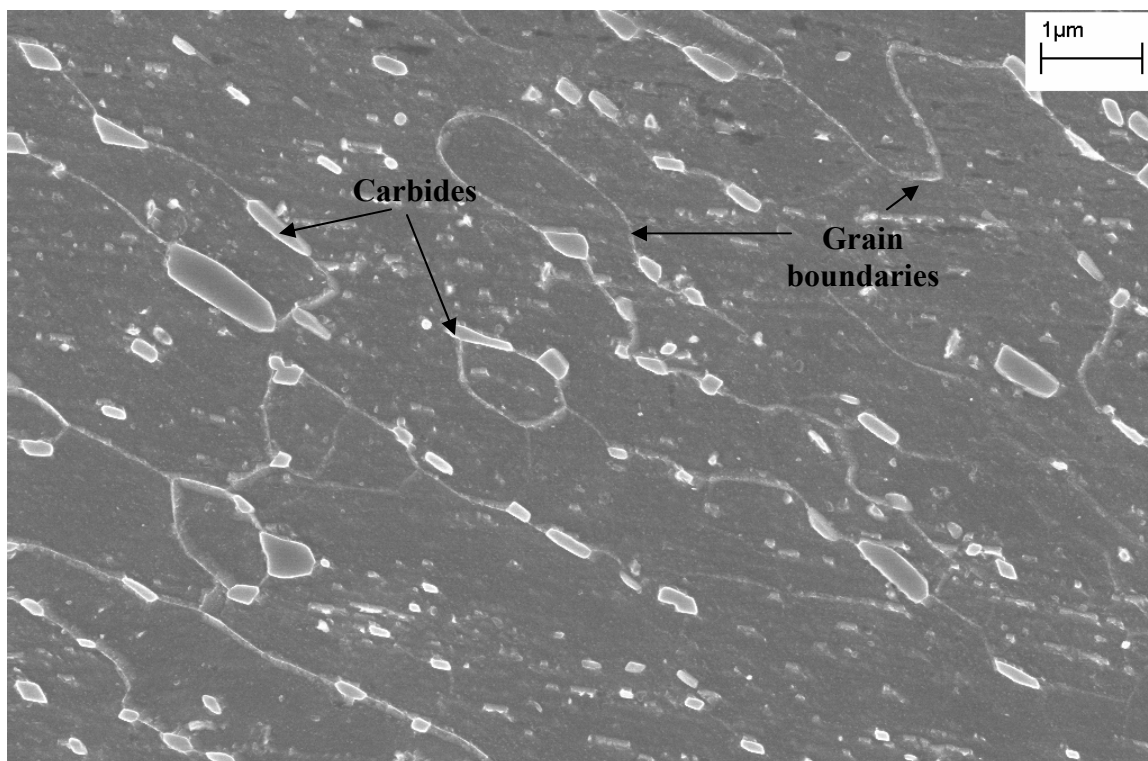
Figure 25 - Figure 8 - SEM image of the microstructure of Tempered 650°C for one week (7 days).

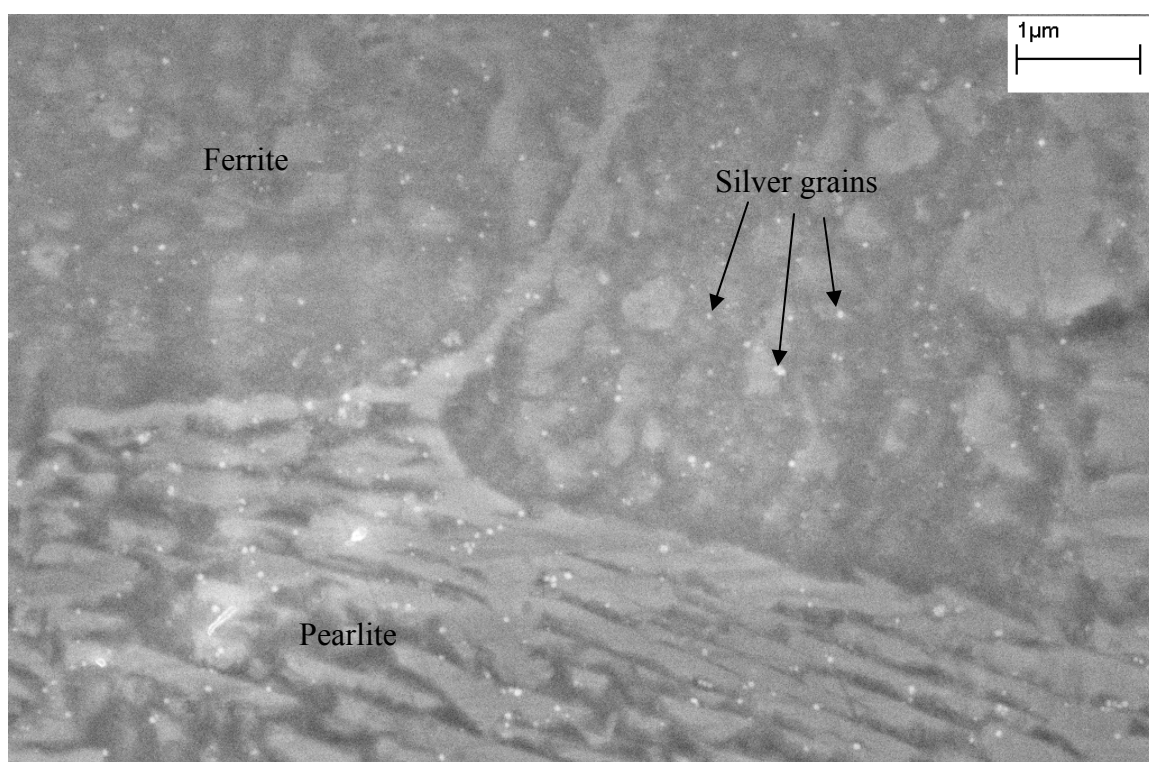
Figure 27 - SEM of hydrogen microprinted as-received sample.

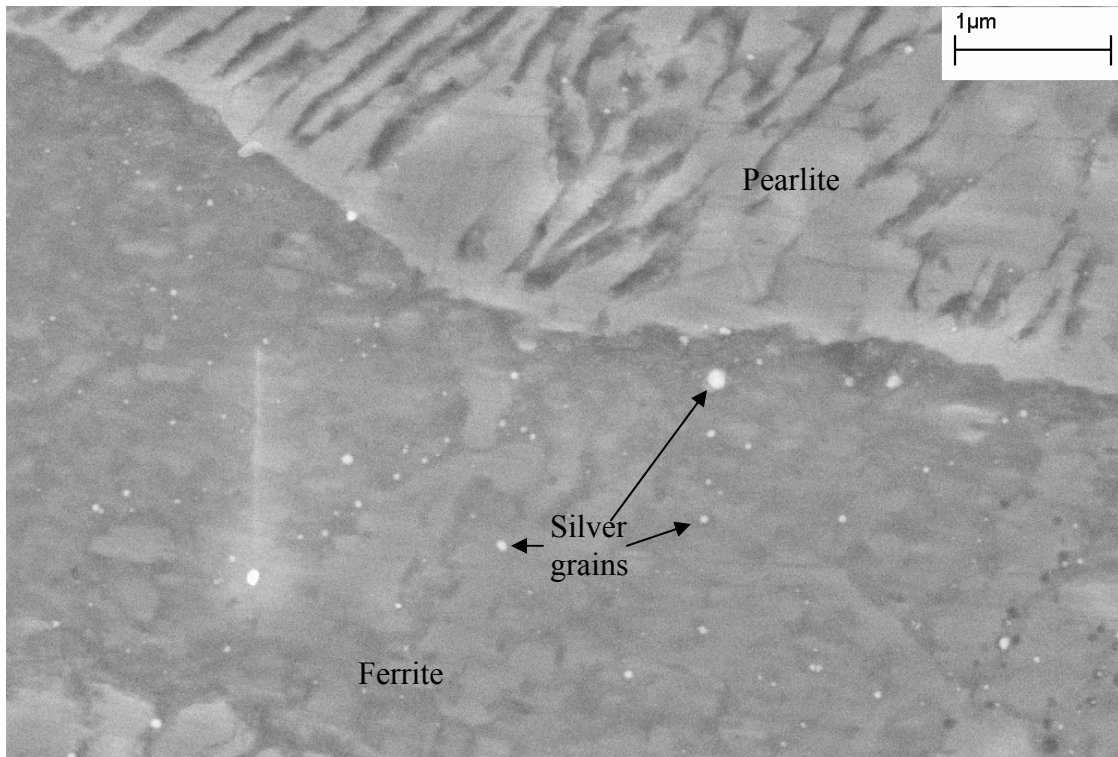
Figure 30 - SEM of hydrogen microprinted annealed sample. As compared to the as machined sample, the annealed sample has a significantly less hydrogen. However, the preference of hydrogen to accumulate within ferrite is still apparent.

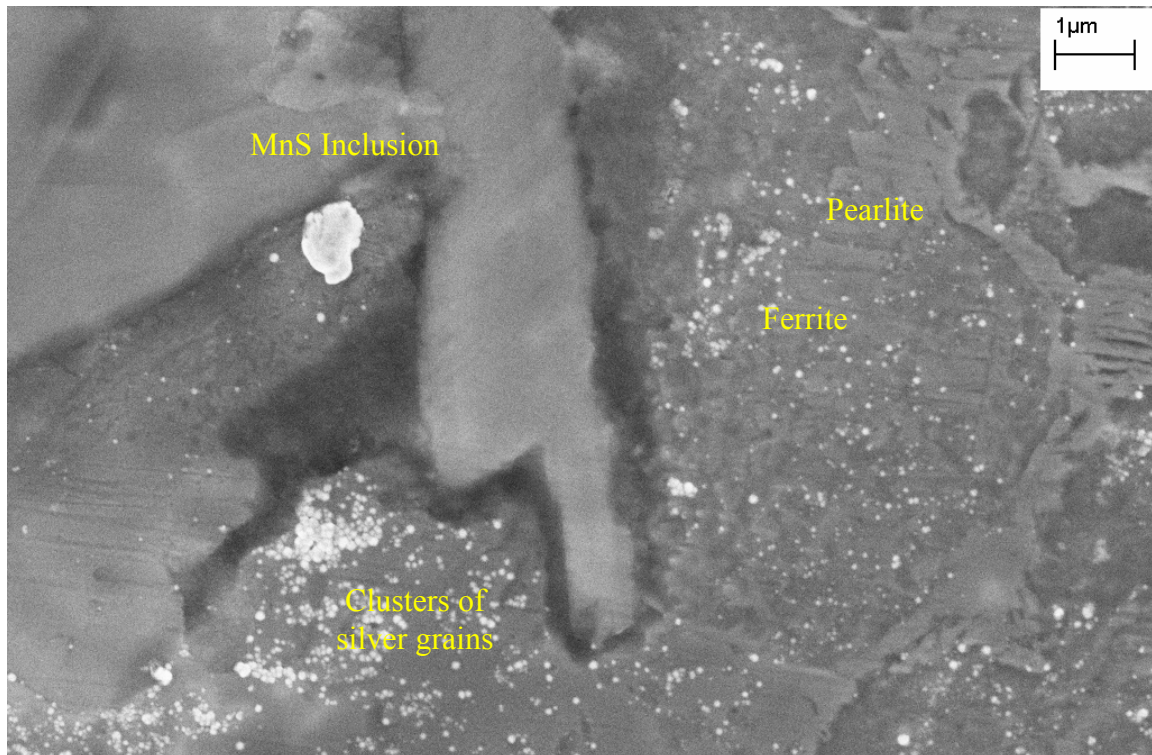
Figure 31 - Hydrogen concentration around a MnS inclusion was much higher than what was observed in the bulk of the sample. Hydrogen concentration around a MnS inclusion was still concentrated in ferrite grains rather than pearlite

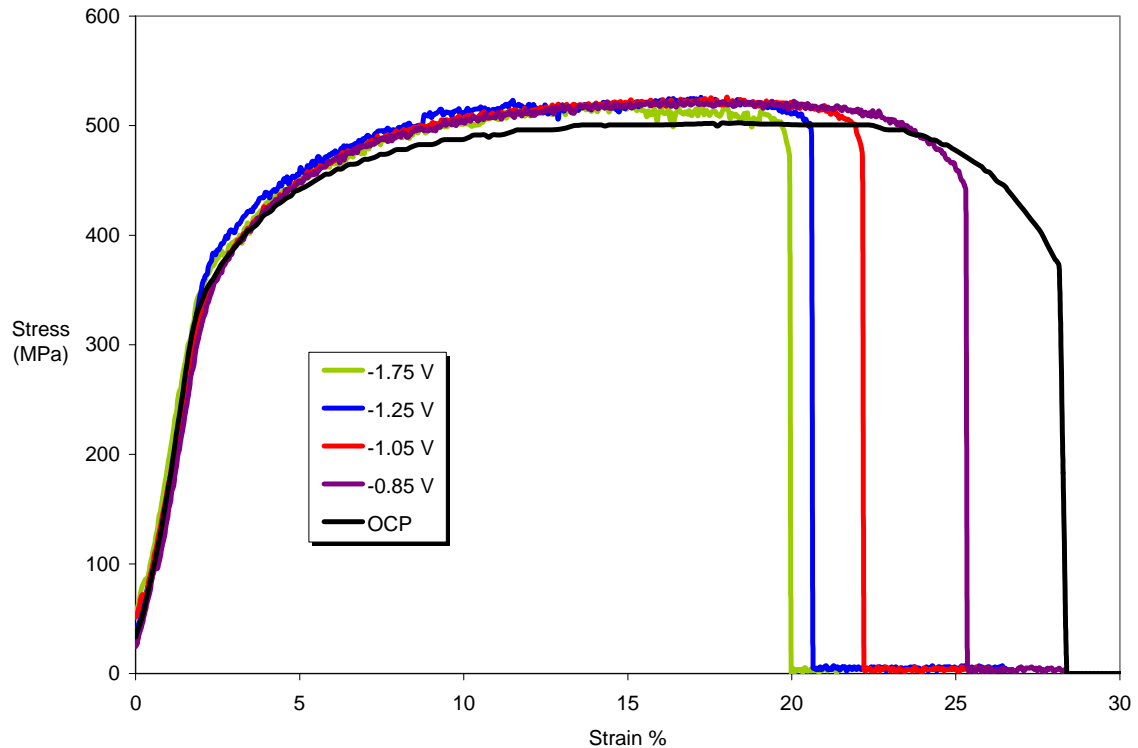
Figure 32 - Effect of Hydrogen Charging on the Mechanical Behavior of X-65 Pipeline Steel during Slow Strain Rate Testing

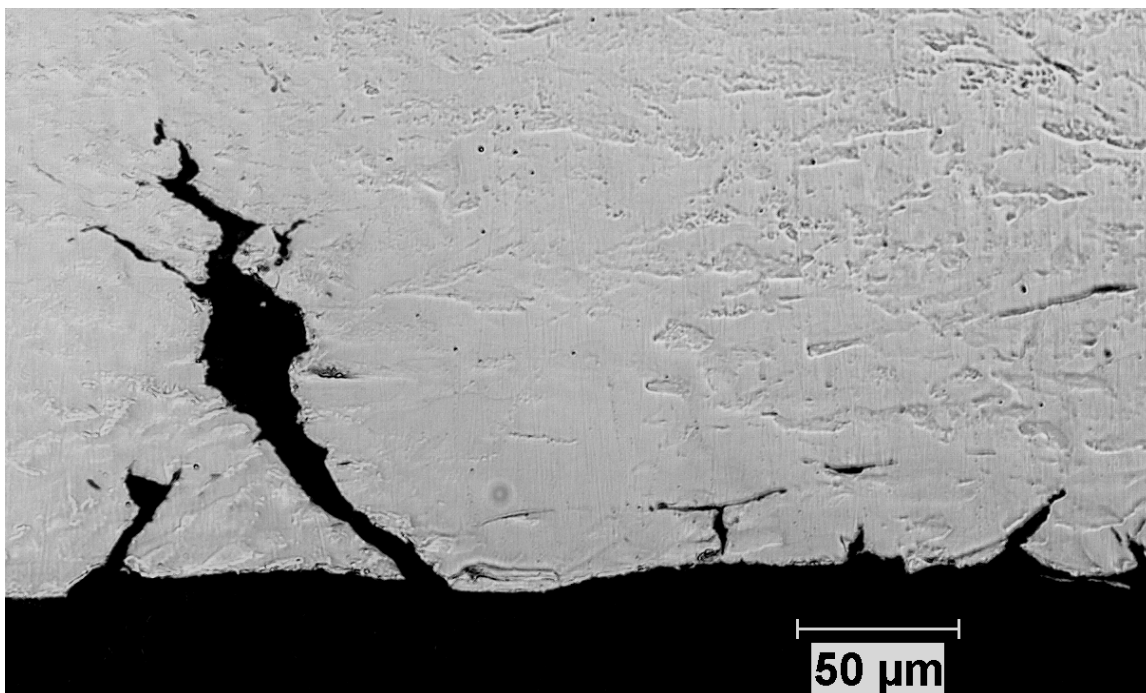
Figure 33 - Crack formed on X-65 pipeline sample exposed to 0.5 g/L NaHCO₃ with 5% CO₂ with -0.850V applied potential at room temperature

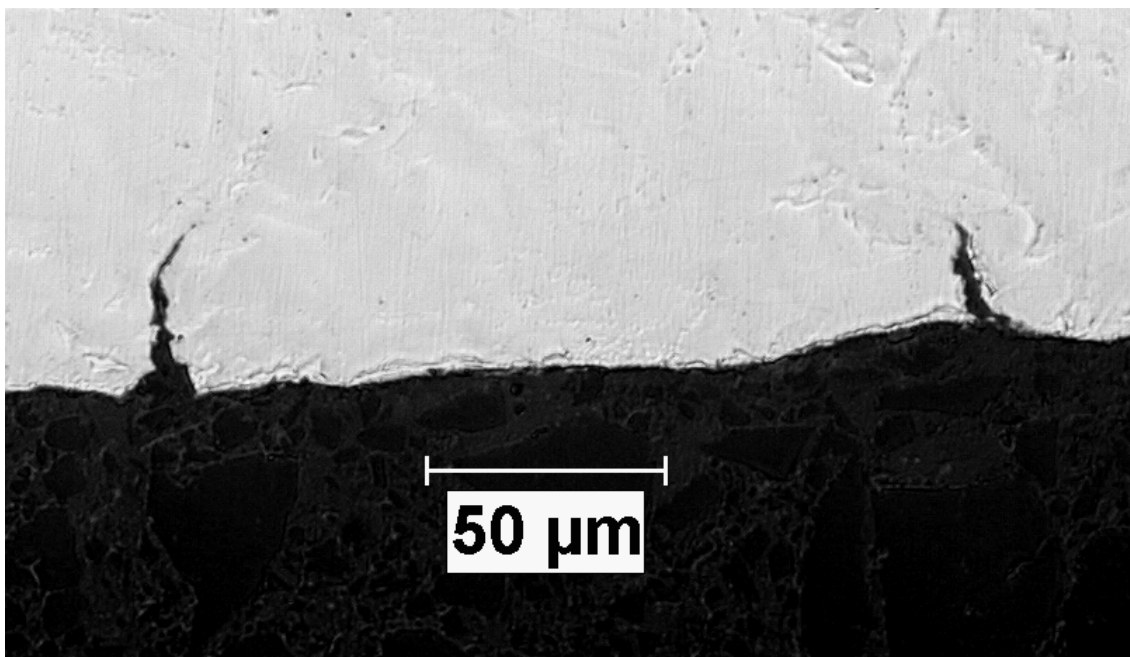
Figure 34 - Crack formed on X-65 pipeline sample exposed to 0.5 g/L NaHCO₃ with 5% CO₂ with -1.05V applied potential at room temperature

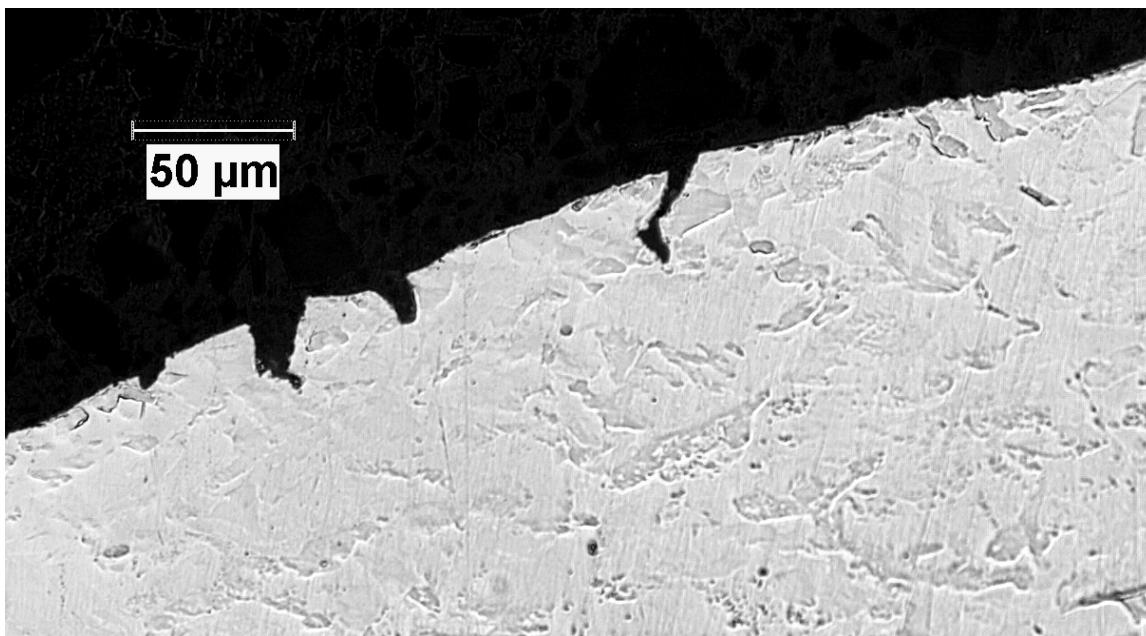
Figure 35 - Crack formed on X-65 pipeline sample exposed to 0.5 g/L NaHCO₃ with 5% CO₂ with -1.25V applied potential at room temperature.

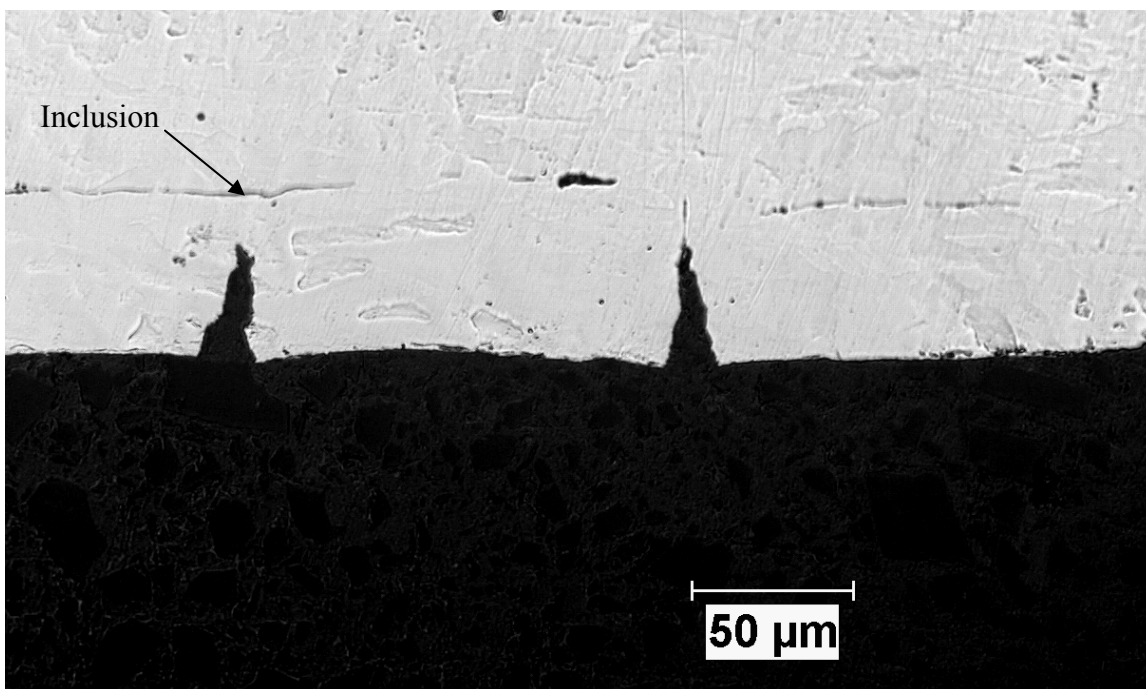
Figure 36 - Crack formed on X-65 pipeline sample exposed to 0.5 g/L NaHCO₃ with 5% CO₂ with -1.75 V applied potential at room temperature cathodic polarization. Note that crack walls are sharp and cracks extend linearly into the sample without significant dissolution of the crack walls.

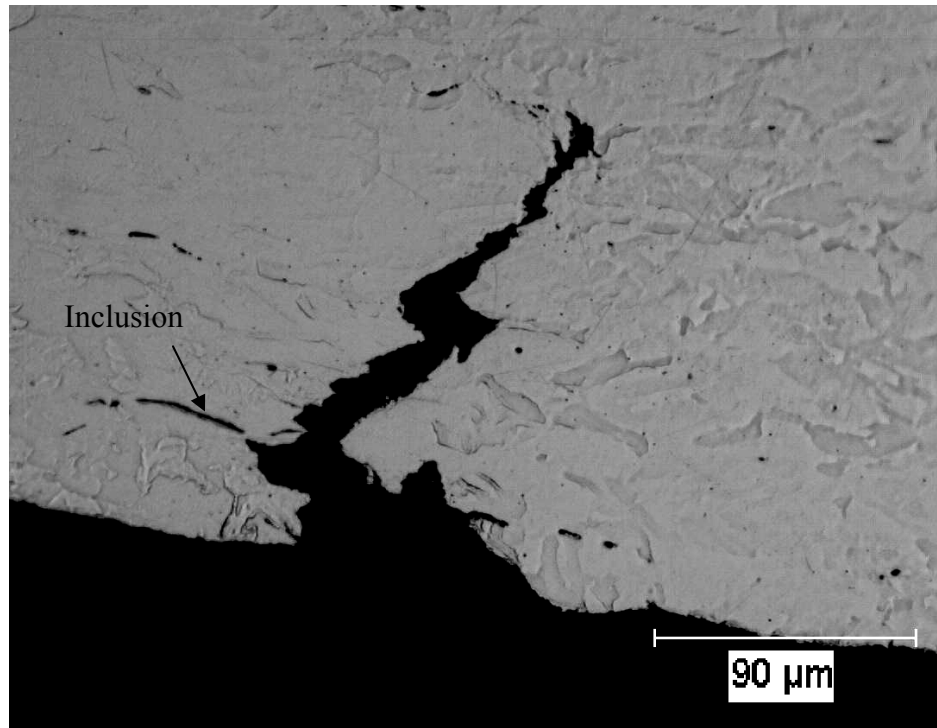
Figure 38 - TGSCC crack that occurred near the fracture surface on an X-65 pipeline sample exposed to 0.5 g/L NaHCO₃ solution with 5% CO₂ at room temperature and OCP

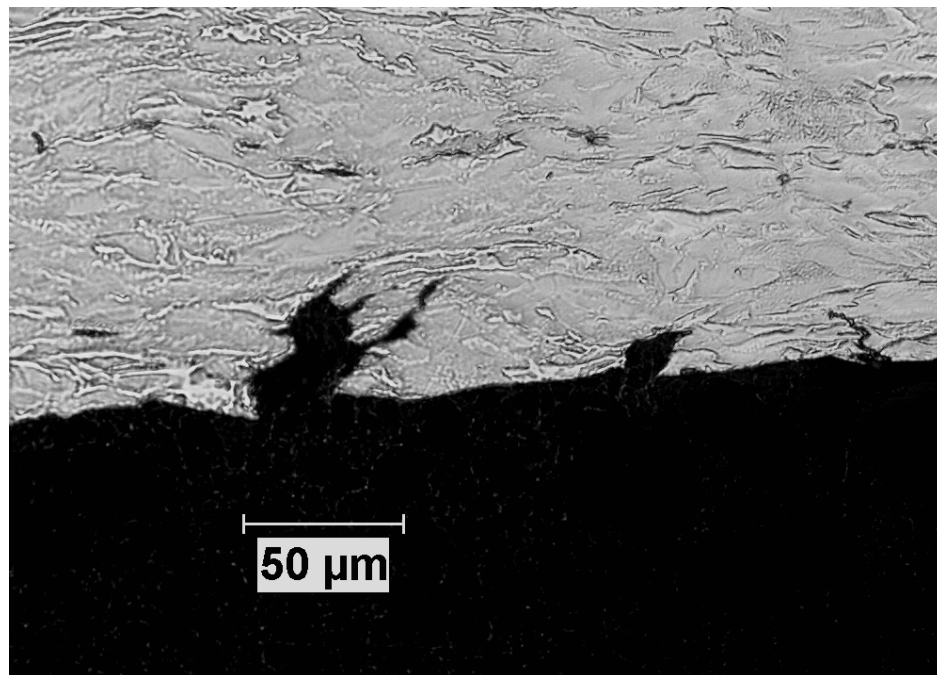
Figure 39 - TGSCC crack formed at the region of necking on an X-65 pipeline sample exposed to 1g/L NaHCO₃ with 5% CO₂ at room temperature and OCP

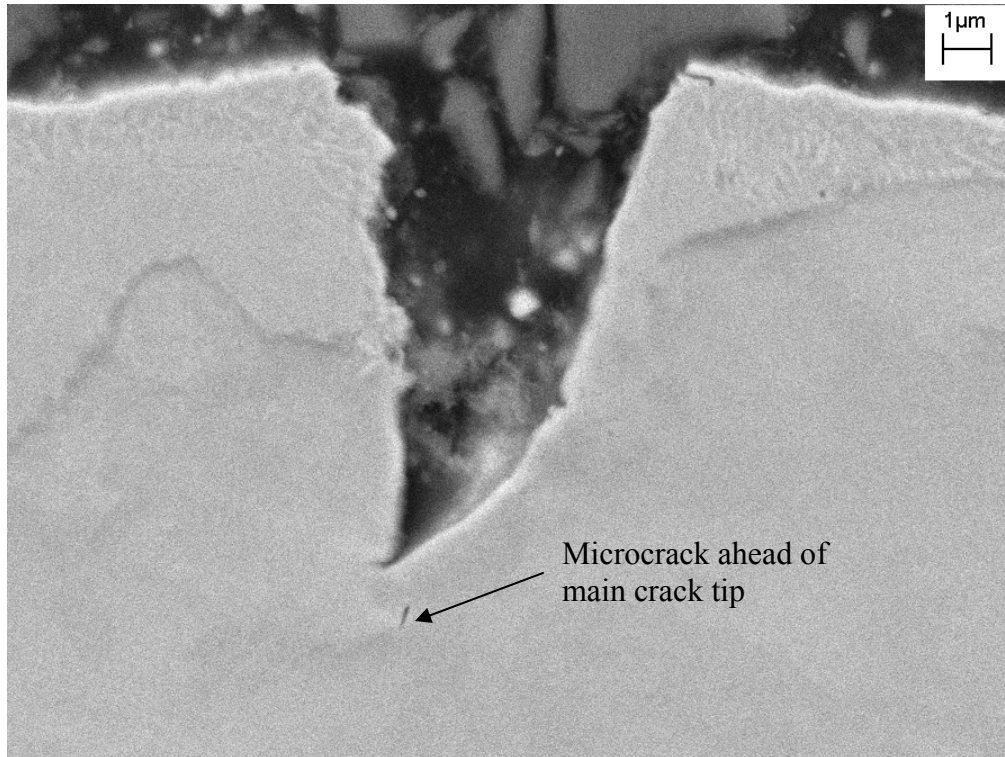
Figure 40 - Microcrack ahead of main crack tip for sample subjected to -1V cathodic potential in 0.5 g/L NaHCO₃ with 5%CO₂ exposure

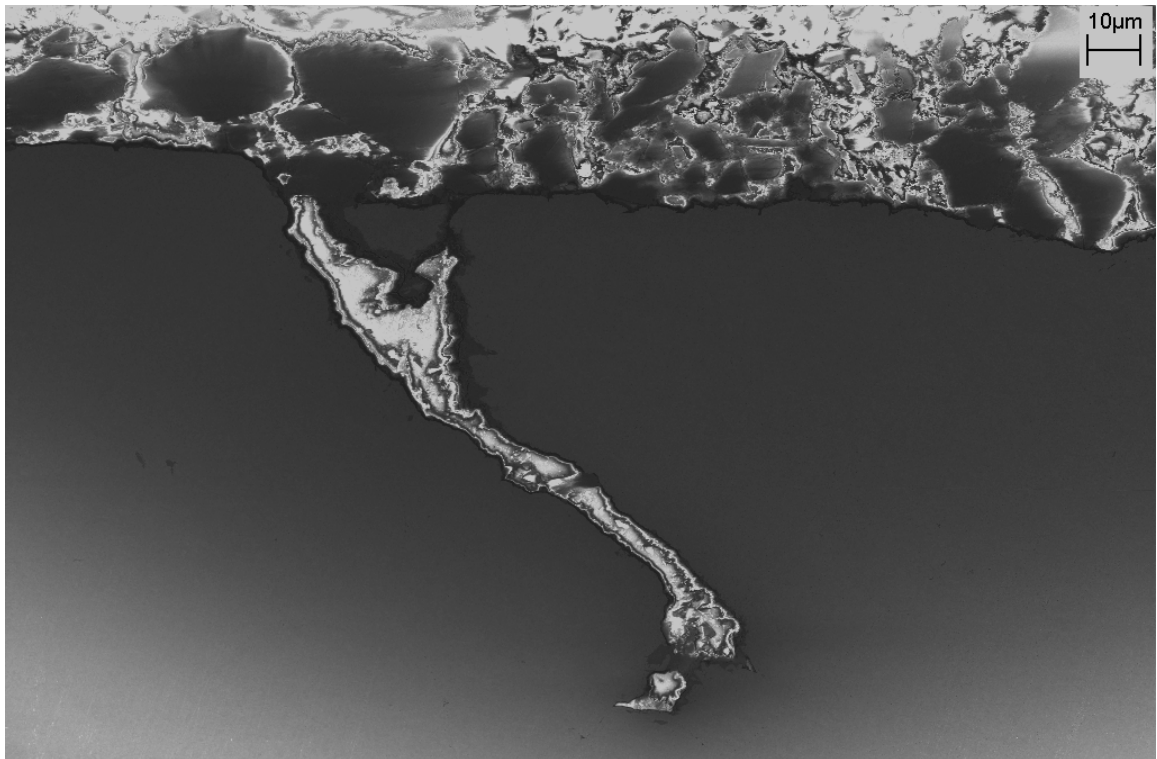
Figure 41 – SEM image of entire crack on slow strain rate sample exposed in 0.1 g/L NaHCO_3 with 5% CO_2 at room temperature. This is the same crack as seen in Figure 37.

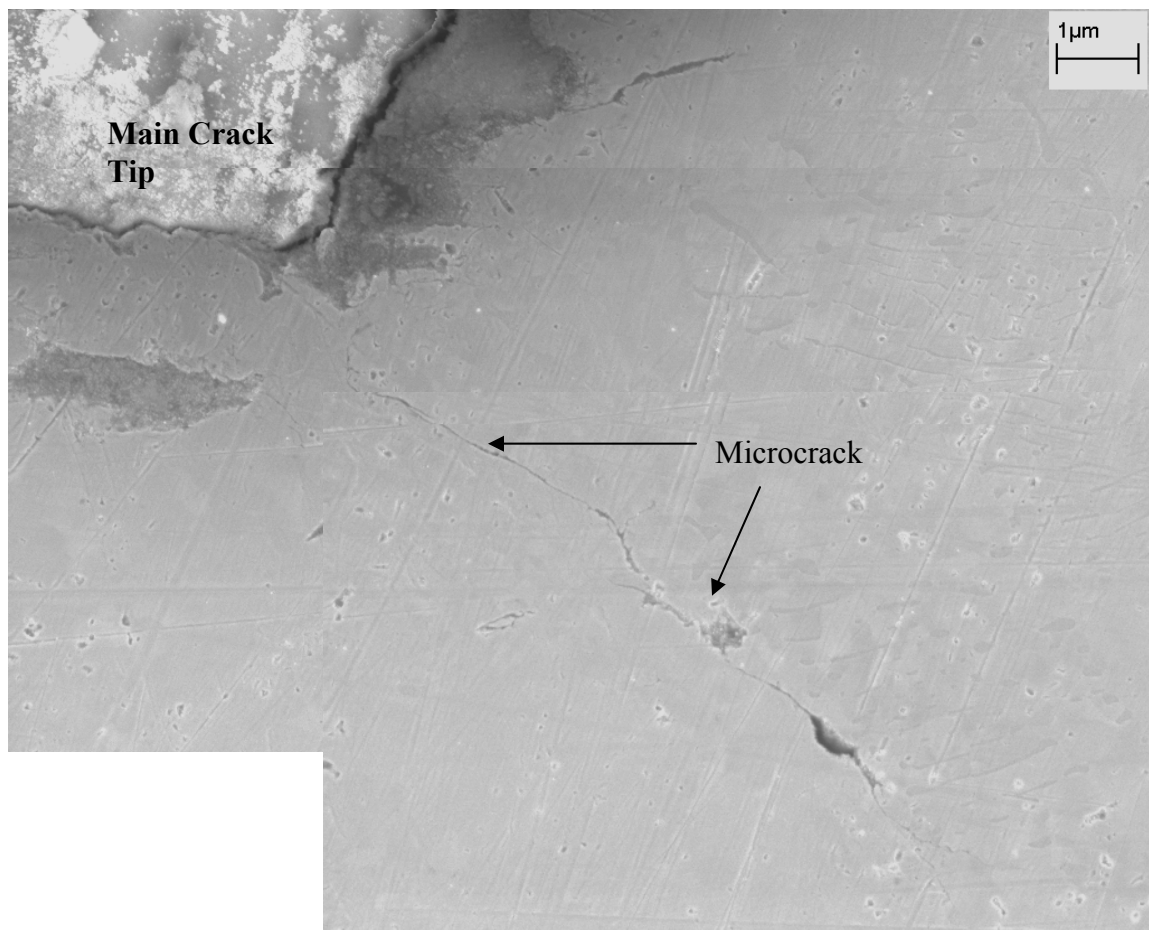
Figure 42 - Microcrack ahead of main crack tip formed on sample exposed to 0.1 g/L NaHCO₃ with 5%CO₂ at room temperature. The microcrack has formed ~10 microns ahead of the main crack tip.

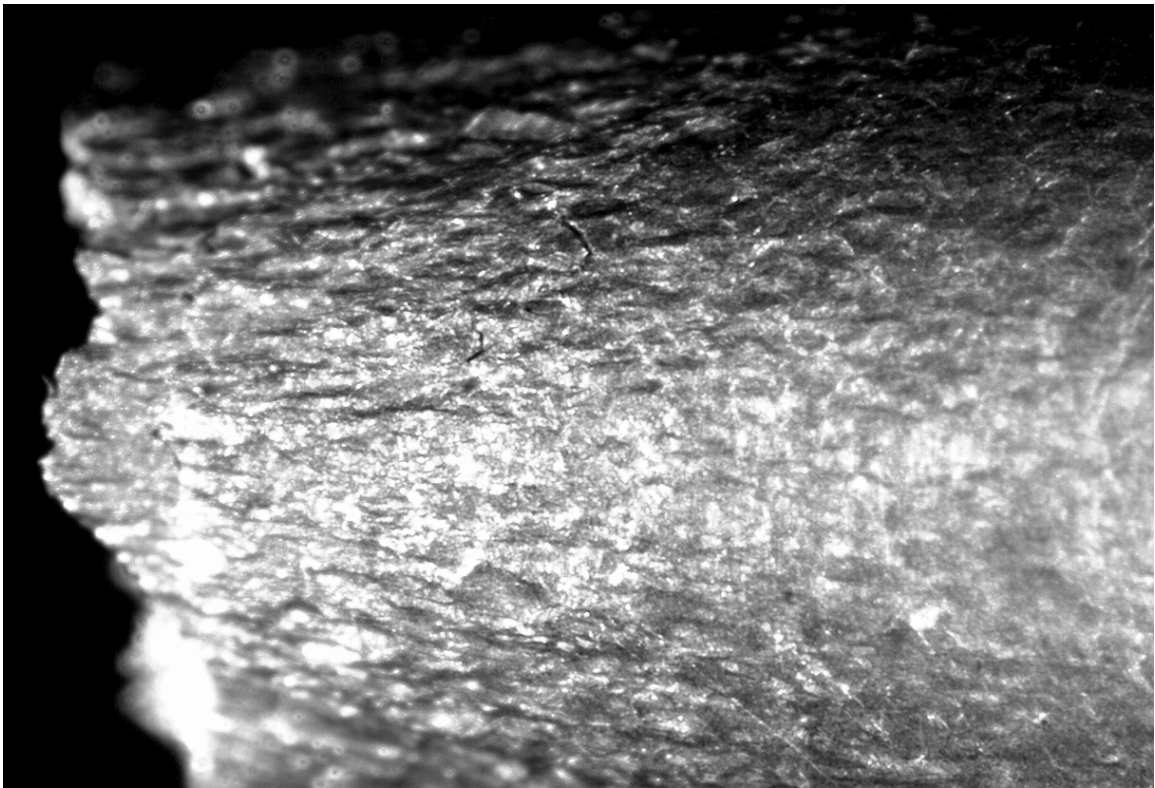
Figure 44 - Gauge surface of normalized sample after failure when exposed to 0.5 g/L NaHCO₃ with 5% CO₂ at room temperature and OCP

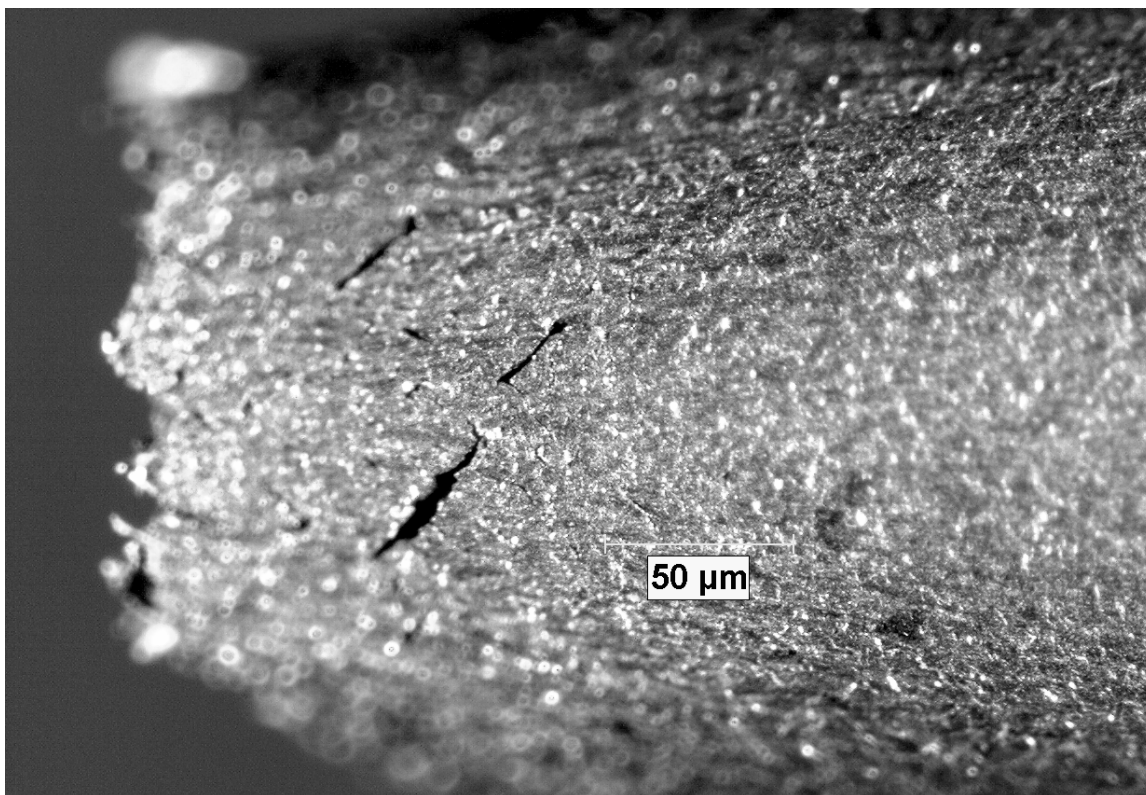
Figure 45 - Gauge surface of as-received sample after failure when exposed to 0.5 g/L NaHCO₃ with 5% CO₂ at room temperature and OCP
